KHANDALLAH POOL SITE ASSESSMENT REPORT

ARCHITECTURE HDT | TONKIN AND TAYLOR | POWELL FENWICK | ADAMSON & SHAW

EXECUTIVE SUMMARY

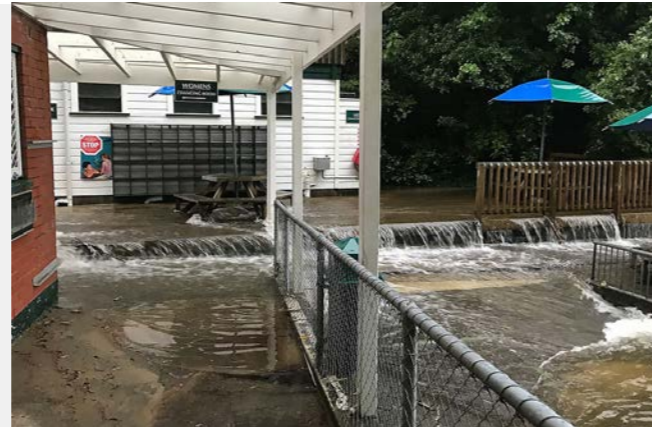
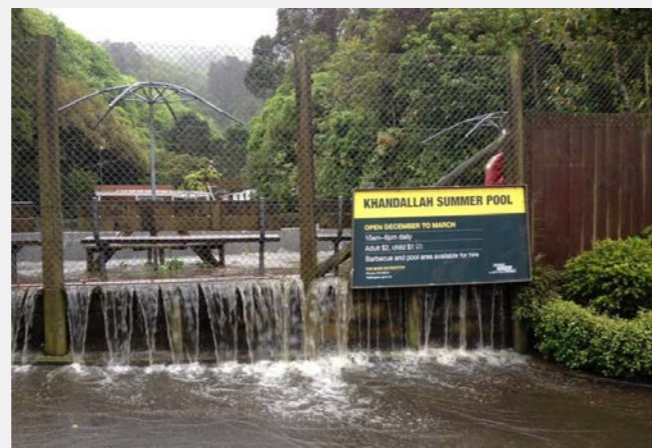
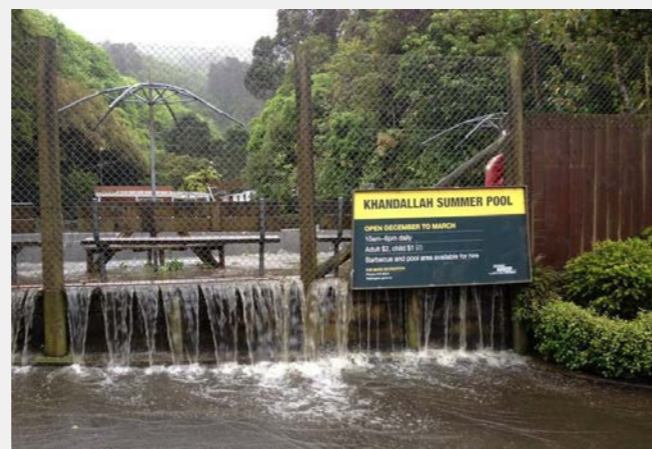
With climate change in mind, two additional scenarios were reviewed by Tonkin and Taylor.

1% AEP rain event +20% rainfall

Wellington Water have flood hazard modelling for a 1% AEP rain event +20% rainfall depth to allow for climate change. Flood hazard modelling for this scenario is given below, with the purpose to identify a safe building platform level and how high rainfall stream flows can be accommodated.

Based on this scenario and modelling, Wellington Water recommends that a level of RL 171.8 be used with appropriate free-board. The Wellington Water Regional Standards for Water Services gives guidance that the minimum free board (top of peak flood level to underside of floor joists/structure) should be 200mm, which suggests that the floor level of any new development be at RL 172.00.

It should be noted that the level of the existing pool concourse is approximately RL 170.00. Mitigating flood risk identified by this modelling would require the site platform to be built up by 1.8-2 metres, or an acceptance that structures with a floor level below RL 171.8 may be subject to flood damage in the future.

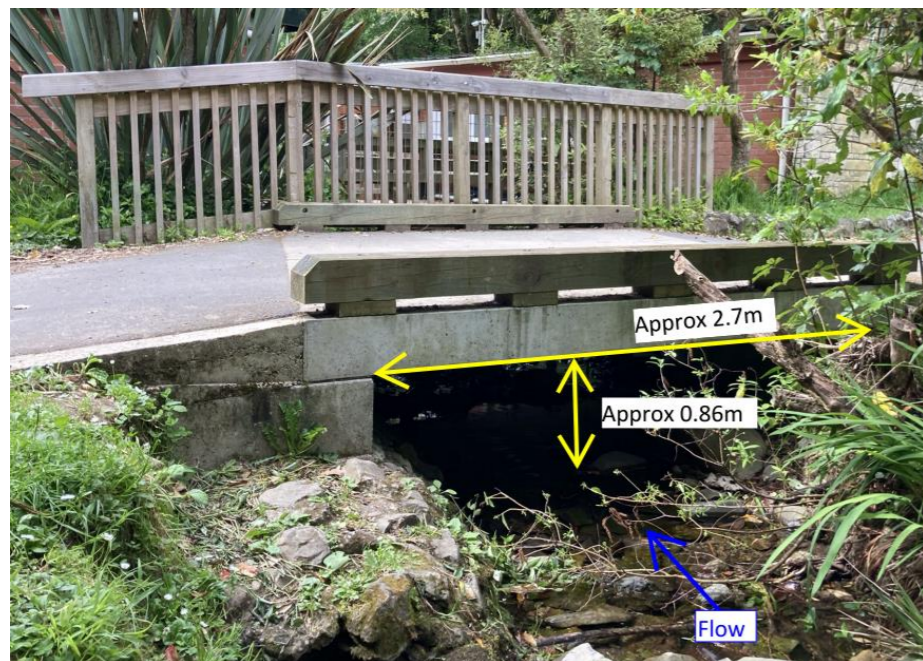
Figure 2.3 Existing footbridge and Tyers Stream located to the west of the site.

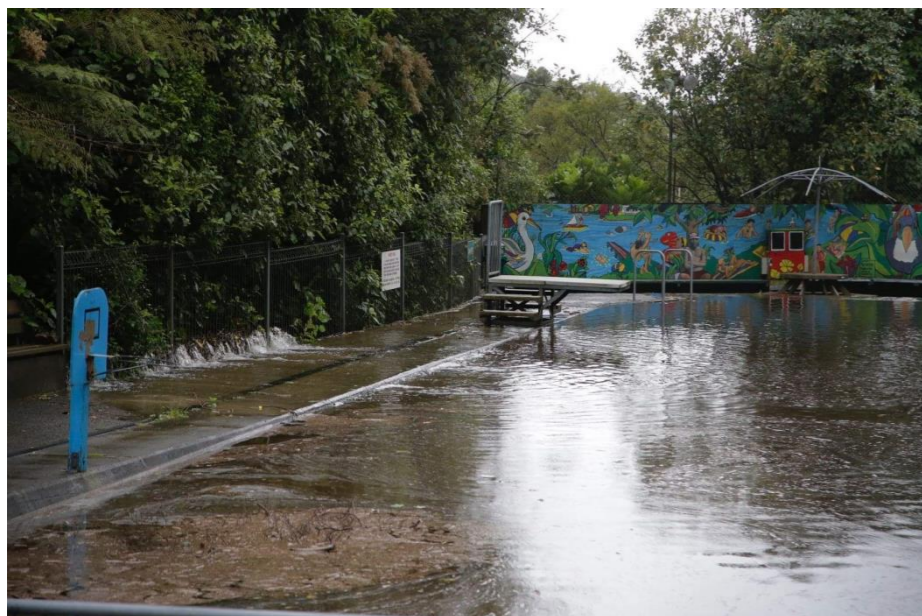
Figure 3.1 Khandallah pool flooding, photo uploaded to Facebook on 15 Nov 2016, photo by Maatten Holl.

The Tyers Stream catchment is approximately 60.6 hectares (as determined by Wellington Water) and has historically been the source of flooding of the pool site on multiple occasions as observed in 2016, 2017, and 2021. It is unknown when the pool has flooded on other occasions, however the rainfall depths associated with the known occurrences were researched using the [Greater Water Environmental Data Dashboard](#) to compare the rainfall depth and intensity with the publicly available HIRDS (High Intensity Rainfall Design System) rainfall data. Based on this research, the observed flooding occurred approximately during present-day 20% AEP rain events. See Table 3.1 and Figure 3.1 to Figure 3.4 below for reference.

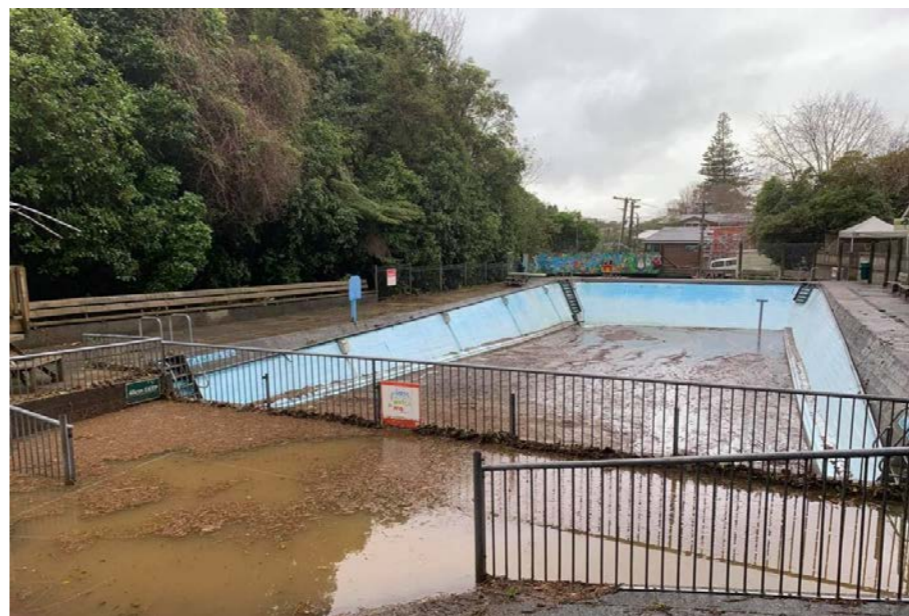
Figure 3.3 Flooding aftermath at the Khandallah Pool, photo published on Facebook 18 July 2021 by Diane Calvert.

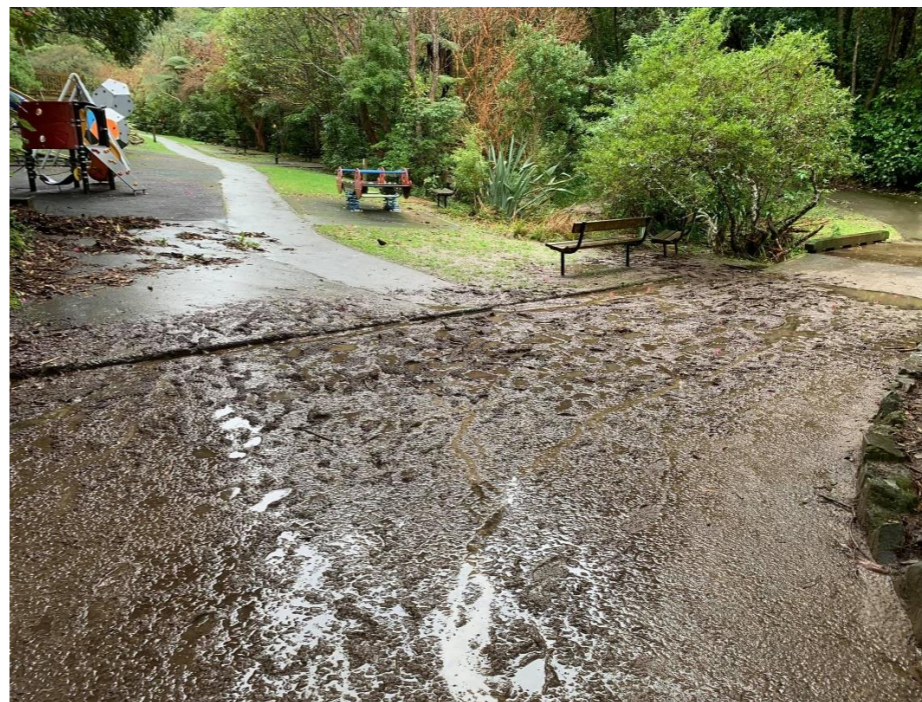
Figure 3.4 Flooding aftermath upstream of the Khandallah Pool, photo published on Facebook 18 July 2021 by Diane Calvert.

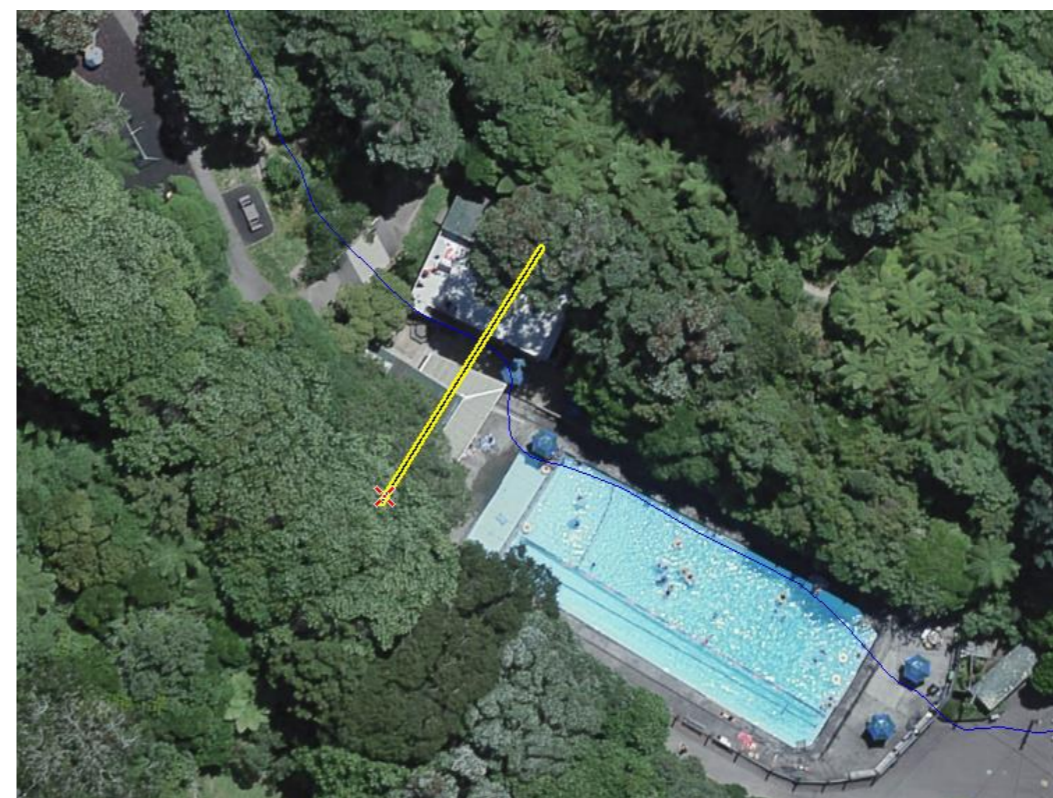
Figure 3.7 HEC-HMS model cross-section location.

First, a HEC-HMS model was developed using rainfall data available on NIWA’s HIRDS site. The catchment and parameters for the model were then developed in accordance with the Wellington Water Reference Guide for Design Storm Hydrology. The catchment size was determined to be 60.76 hectares, which is similar to what Wellington Water’s model used (60.6 hectares), and the HEC-HMS modelling calculated stream flows for the rain event. Openflows Flowmaster was then used to calculate the flow velocity and maximum flood level elevation at the Khandallah Pool catchment. Lidar was used for the catchment surface data, and the pool constraints to the northwest (where the stream flows beneath the footbridge and pool deck) were not incorporated in order to compare with the Wellington Water model. See Figure 3.7 and Figure 3.8 for a cross-sectional view of the assessed portion of the pool site.

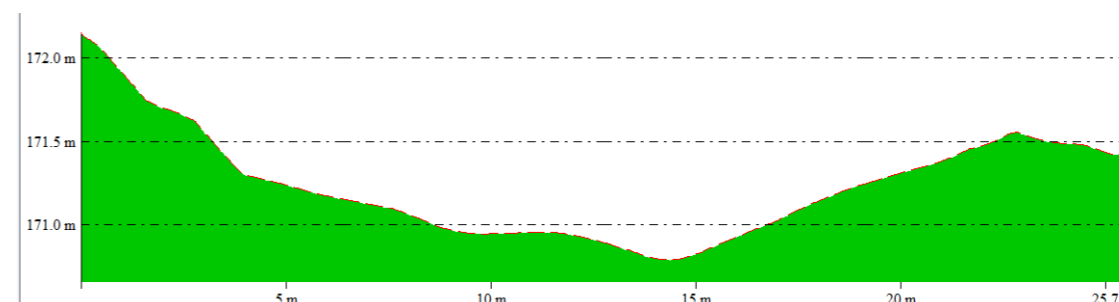
Figure 3.8 HEC-HMS model cross-section (looking downstream). Note, the topography is shown in green based on lidar, which has limited accuracy. The pool deck or buildings have not been incorporated in the model as a constraint in order to compare with Wellington Water’s model results.

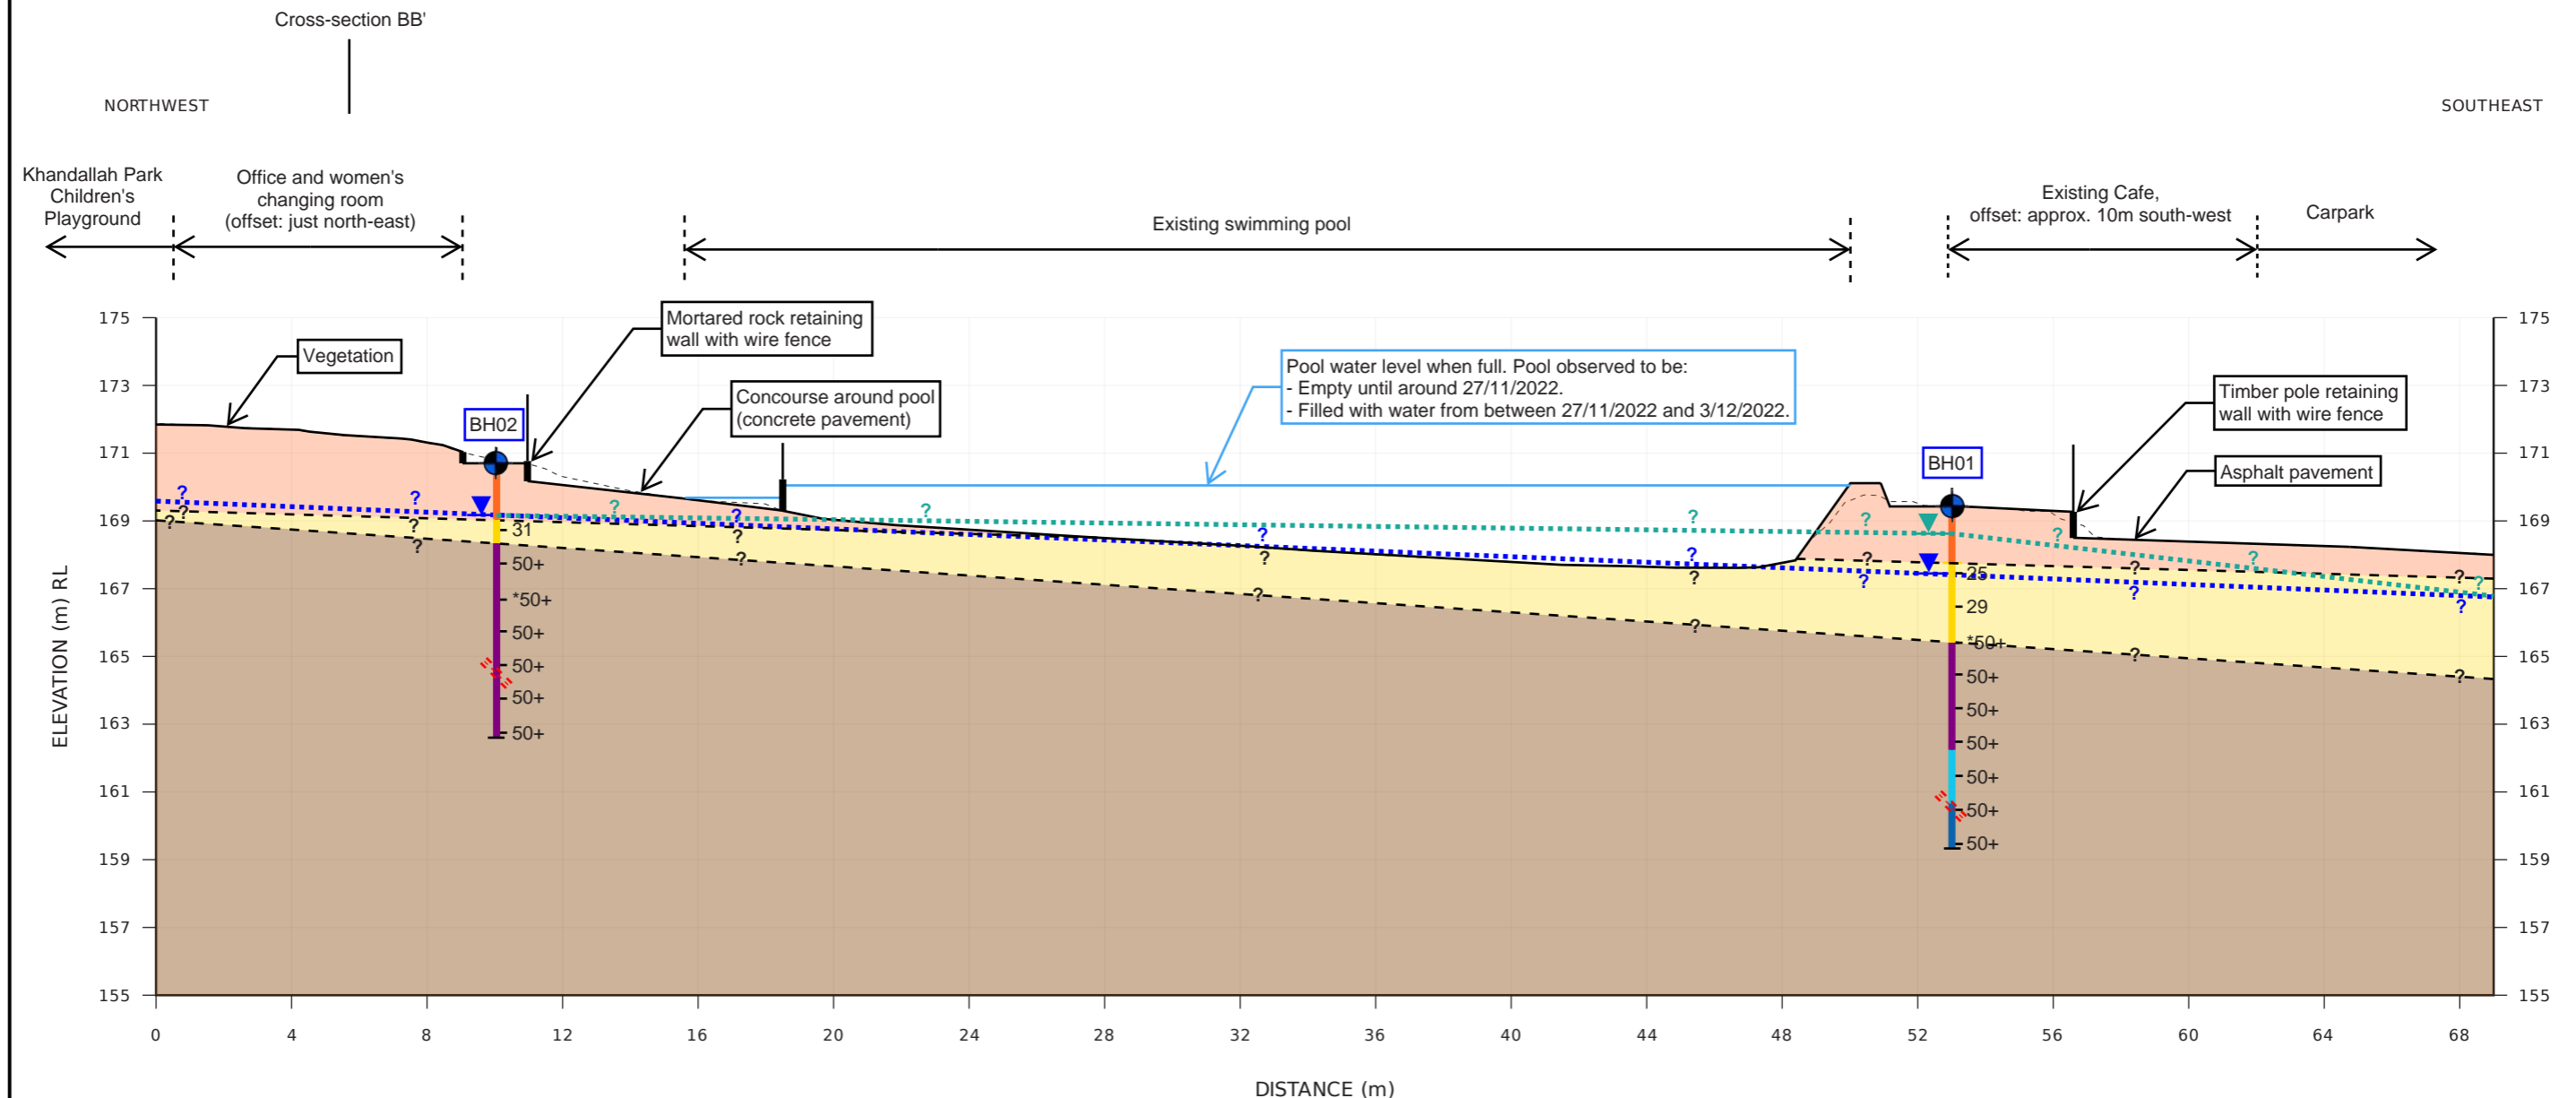
SECTION AA'
SCALE: 1:200

T+T Cross-Section Generator (CSG)
 Start Point (NZTM): 1749824.84 mE, 5432857.09 mN
 End Point (NZTM): 1749885.36 mE, 5432824.48 mN
 Date Generated: 2022-11-29, 13:44:49
 CSG Version: 2.0 (Second Release)
 Vertical Datum: Investigation RLs are shown in NZVD2016 datum.
 Groundline Source: LiDAR data licenced by: Wellington City Council. Dataset: Wellington City LiDAR (2019-2020).

- Figure A1 – Site plan (larger scale), presenting published geological information.
- Figure A2 – Site plan (smaller scale), presenting recent geotechnical investigations.
- Figure A3 – Geological cross-section AA'
- Figure A4 – Geological cross-section BB'

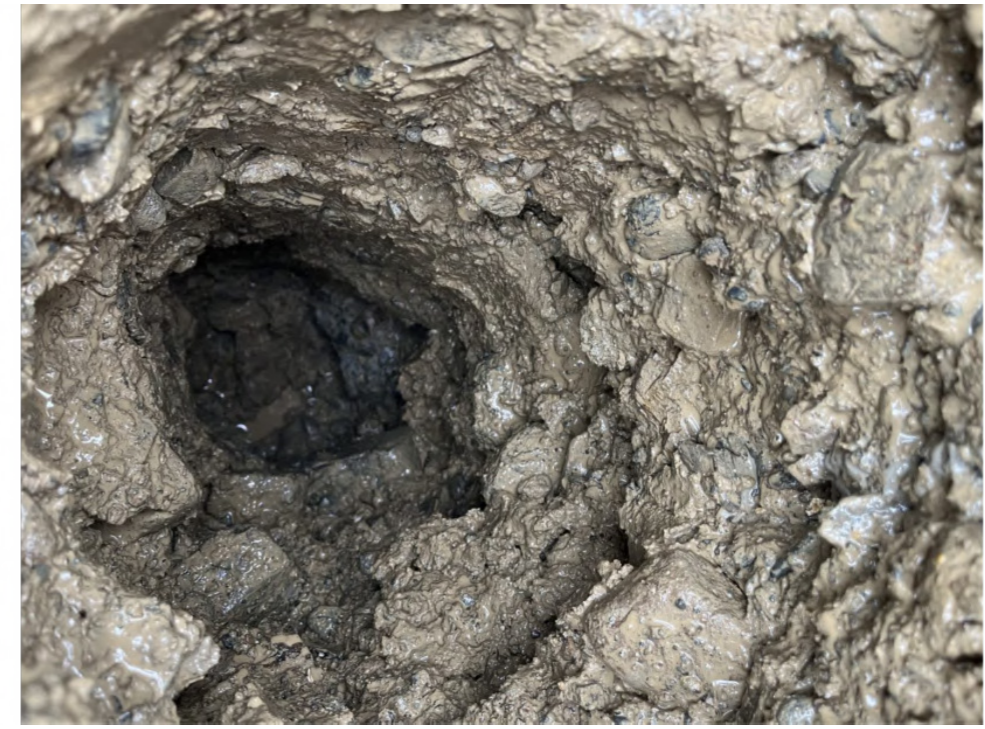
0.00-1.25m: HVAC

BOREHOLE No.: **BH01**
 Hole Location: South-eastern side of existing public pool. About halfway between pool and existing wire and post fence.
 SHEET: 1 OF 4

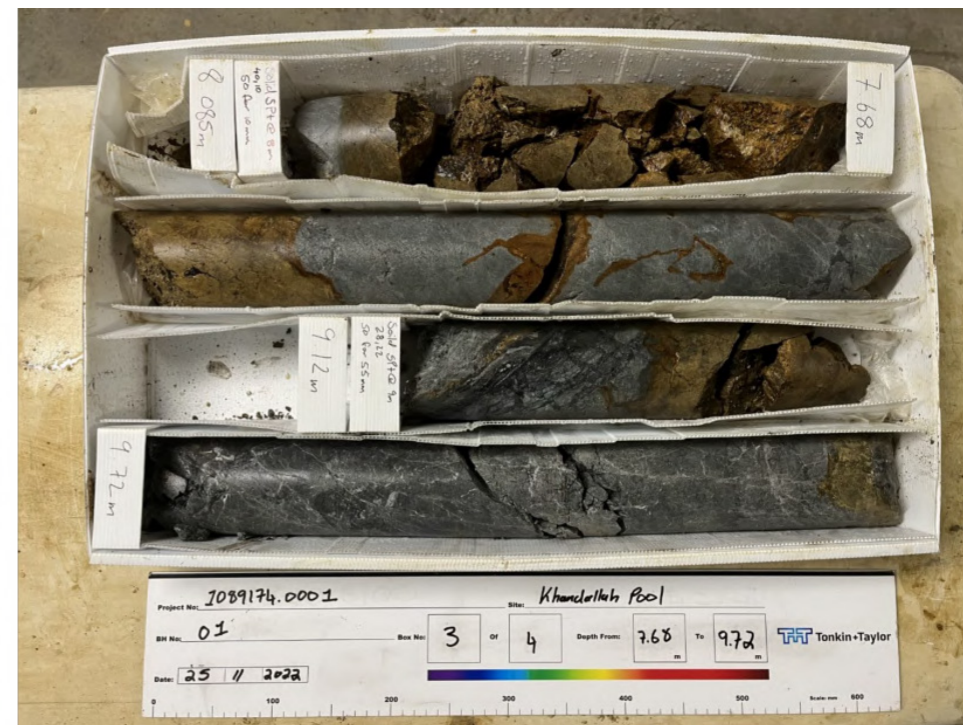
7.68-9.72m

CORE PHOTOS

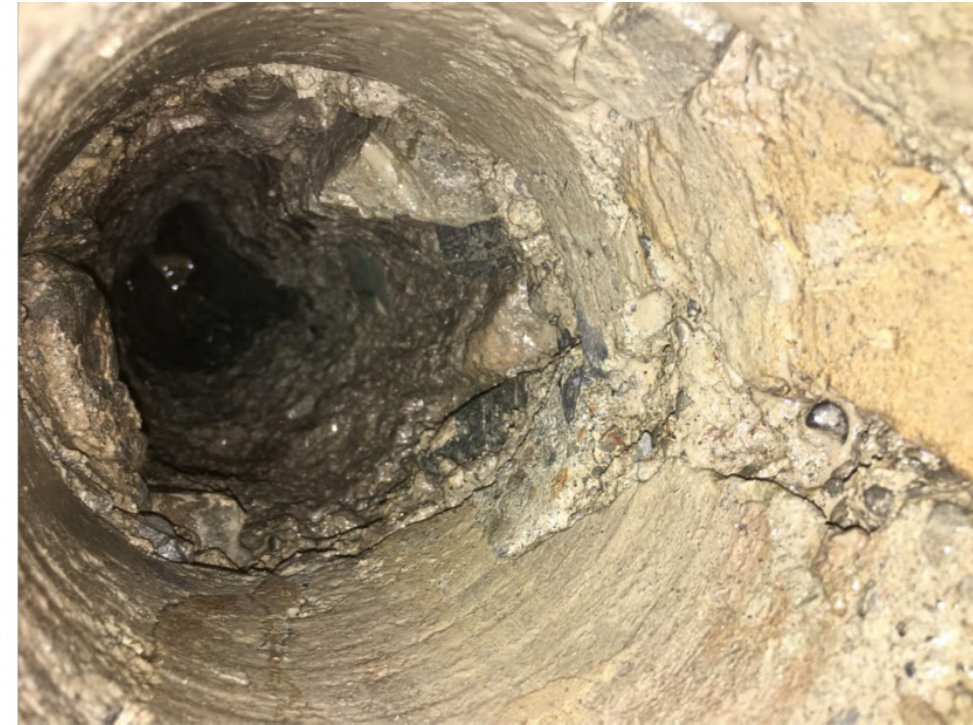
0.00-1.40m: HVAC

BOREHOLE No.: **BH02**
 Hole Location: North-western side of existing public pool. In middle of footpath into pool area, just outside (south-west) of gateway.
 SHEET: 1 OF 3

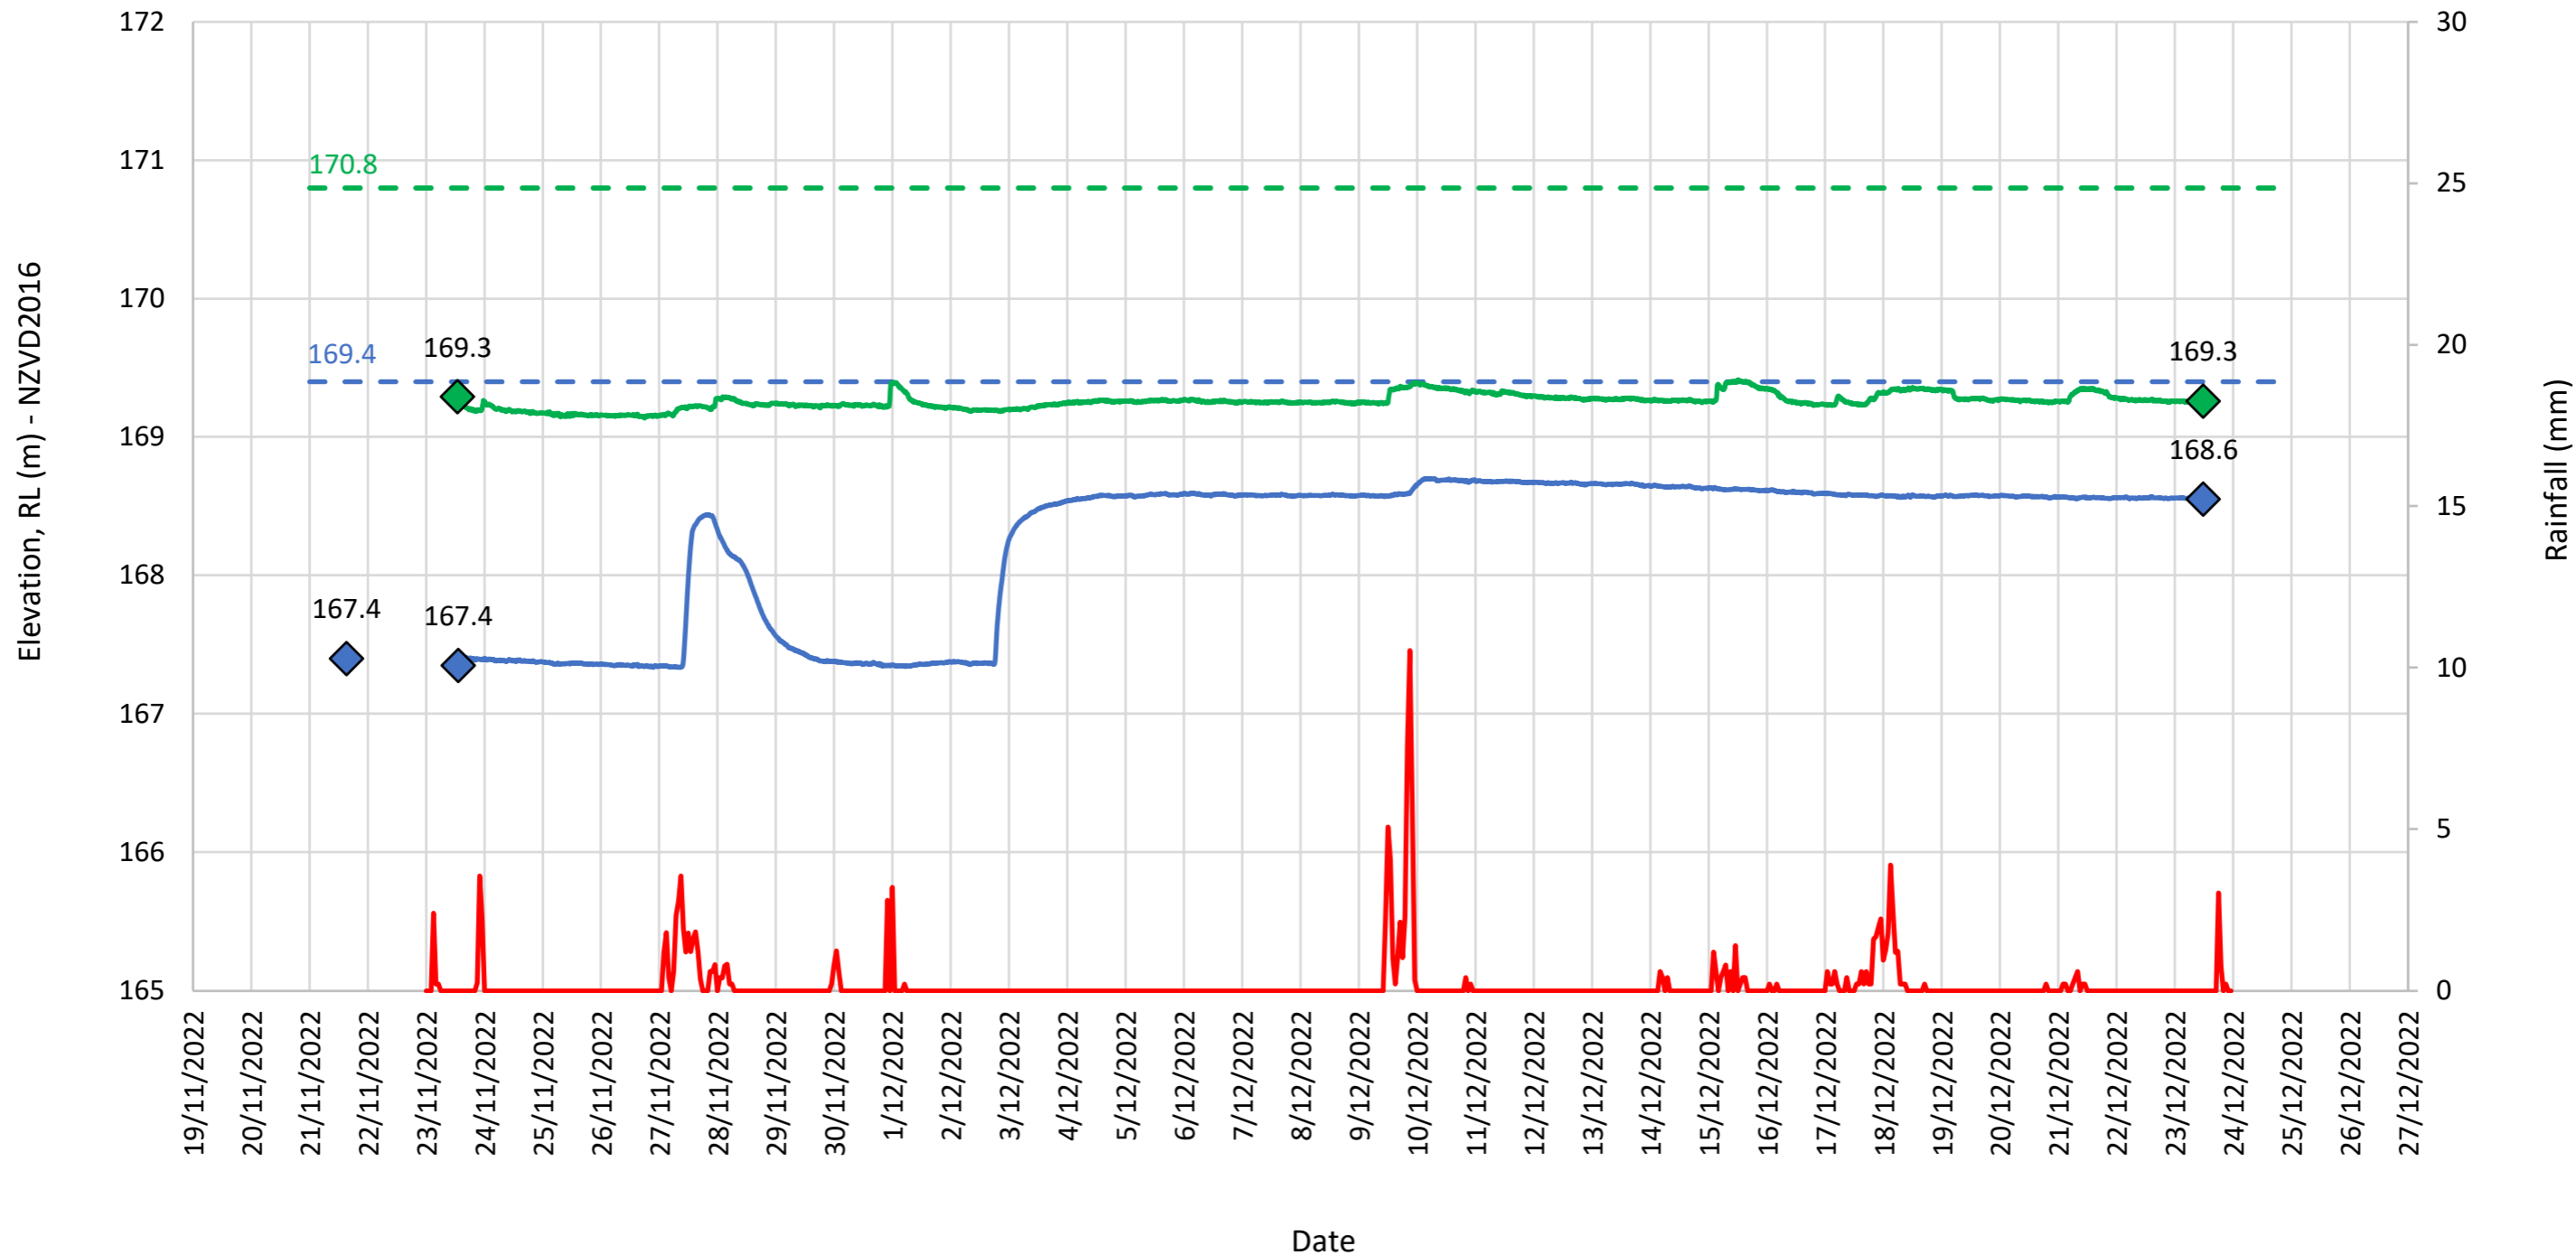
Khandallah Pool - Groundwater level (BH01 and BH02) and rainfall

- - - Existing ground surface level at BH01
 - ◆ Groundwater level (BH01, dip meter)
 - Groundwater level (BH01, level logger)
 - - - Existing ground surface level at BH02
 - ◆ Groundwater level (BH02, dip meter)
 - Groundwater level (BH02, level logger)
- Rainfall (Kaiwharawhara Stream at Ngaio Reservoir)
